FRCC System Disturbance
and
Underfrequency Load Shedding Event
Report
February 26th, 2008 at 1:09 pm

**Final Report Issued by: FRCC Event Analysis Team
October 30, 2008**

FRCC System Disturbance and Underfrequency Load Shedding Event February 26th, 2008 at 1:09 pm

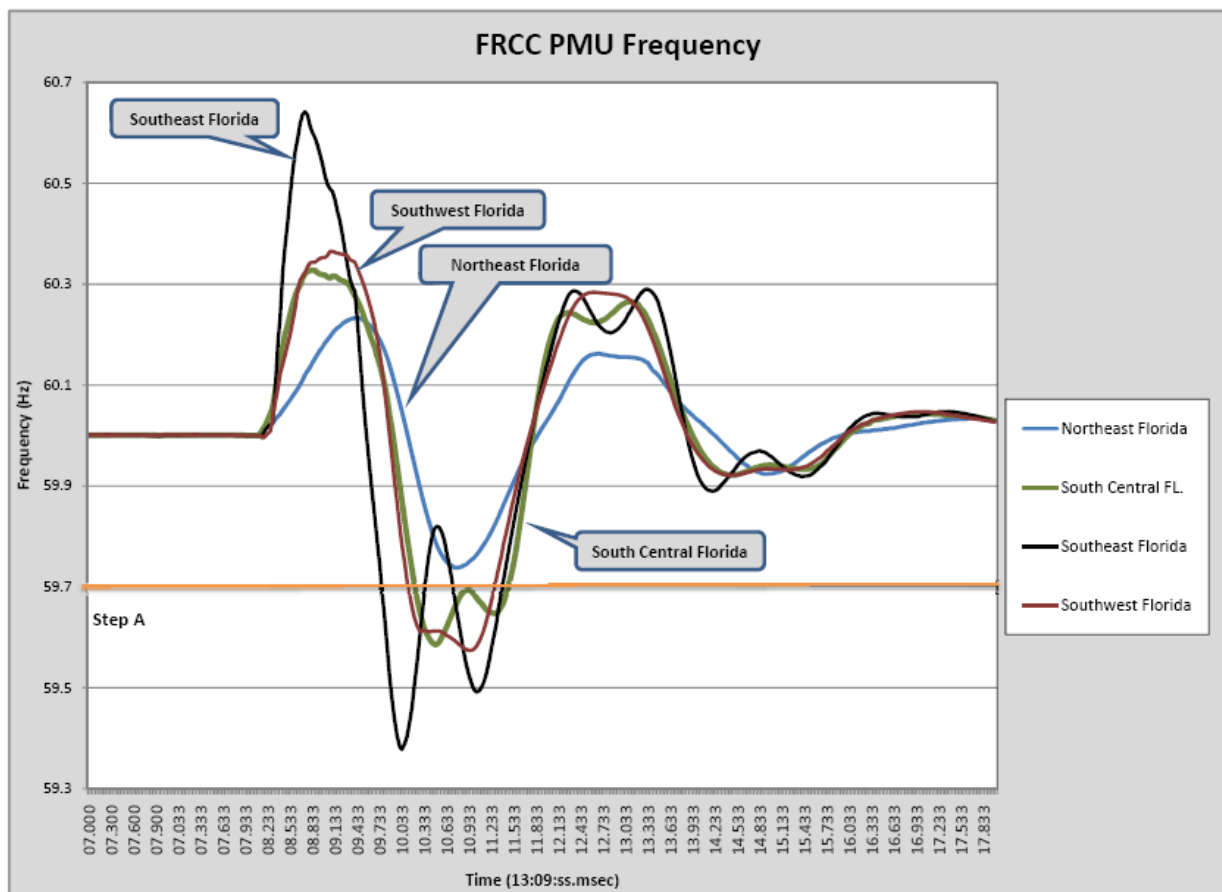
Remote clearing of the fault led to delayed clearing which resulted in the fault remaining on the system for 1.7 seconds. The long duration of the fault resulted in severely depressed voltages in the vicinity of the Turkey Point generating site which led to as designed protective equipment trips of the two nuclear generating units and one of the fossil units at that site. The fault also caused an electromechanical power imbalance on the generators in the South Florida area that resulted in large swings in frequency, power, and voltages that radiated northward through the Region.

The peninsular nature of the Florida system coupled with the delayed clearing of the fault resulted in a damped, frequency swing, with initial amplitude of approximately +/- 0.6 Hz in Southeast Florida and +/- 0.3 Hz in Northeast Florida. The frequency swing (initiated by the acceleration of generation responding to the fault), along with the resulting voltage perturbations, radiated northward in the Region and resulted in additional fossil generation tripping off-line, primarily due to over-frequency impacts on combustion turbine fuel systems or low voltage impacts on generator auxiliary equipment.

Figure 1 - Measured frequency perturbation across the Region

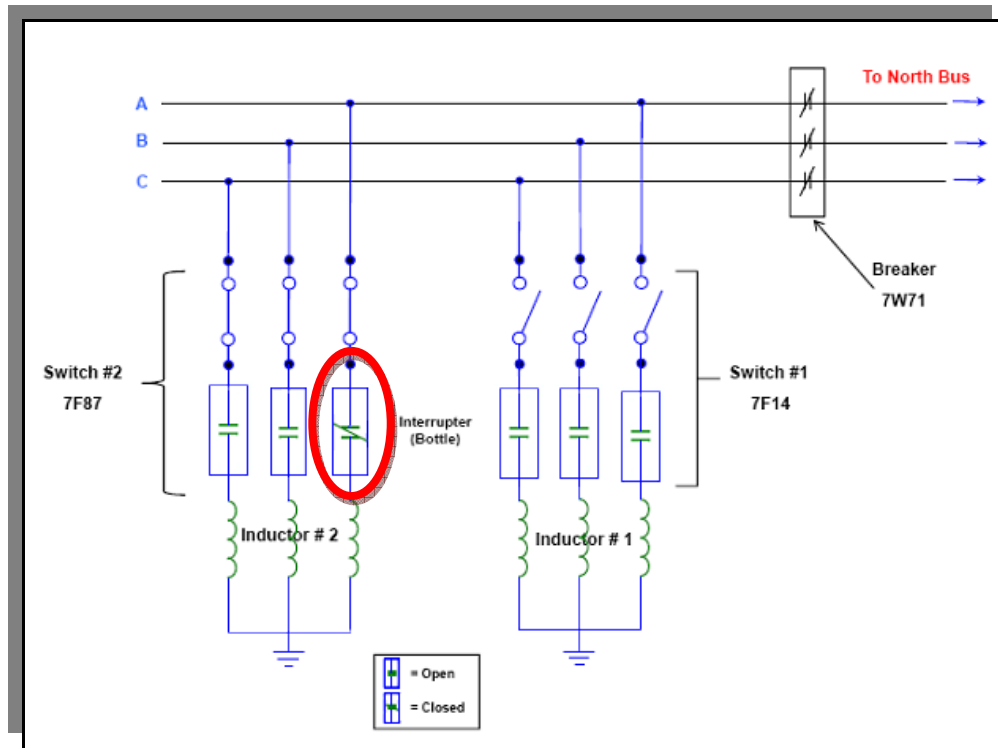
Post event analysis of the failed switch components found that a failed internal interrupting contact mechanism had caused one of the switch interrupters to fail in the closed position.

There was also a coincidental failure of an internal pressure indicator (gas semaphore) identified. The failed semaphore had failed to actuate on loss of insulating gas pressure within the interrupter which if actuated would have likely halted all troubleshooting activities.

Figure 2 – Pre-Fault - Interrupter contact mechanism failed closed – disconnecting contact in closed position

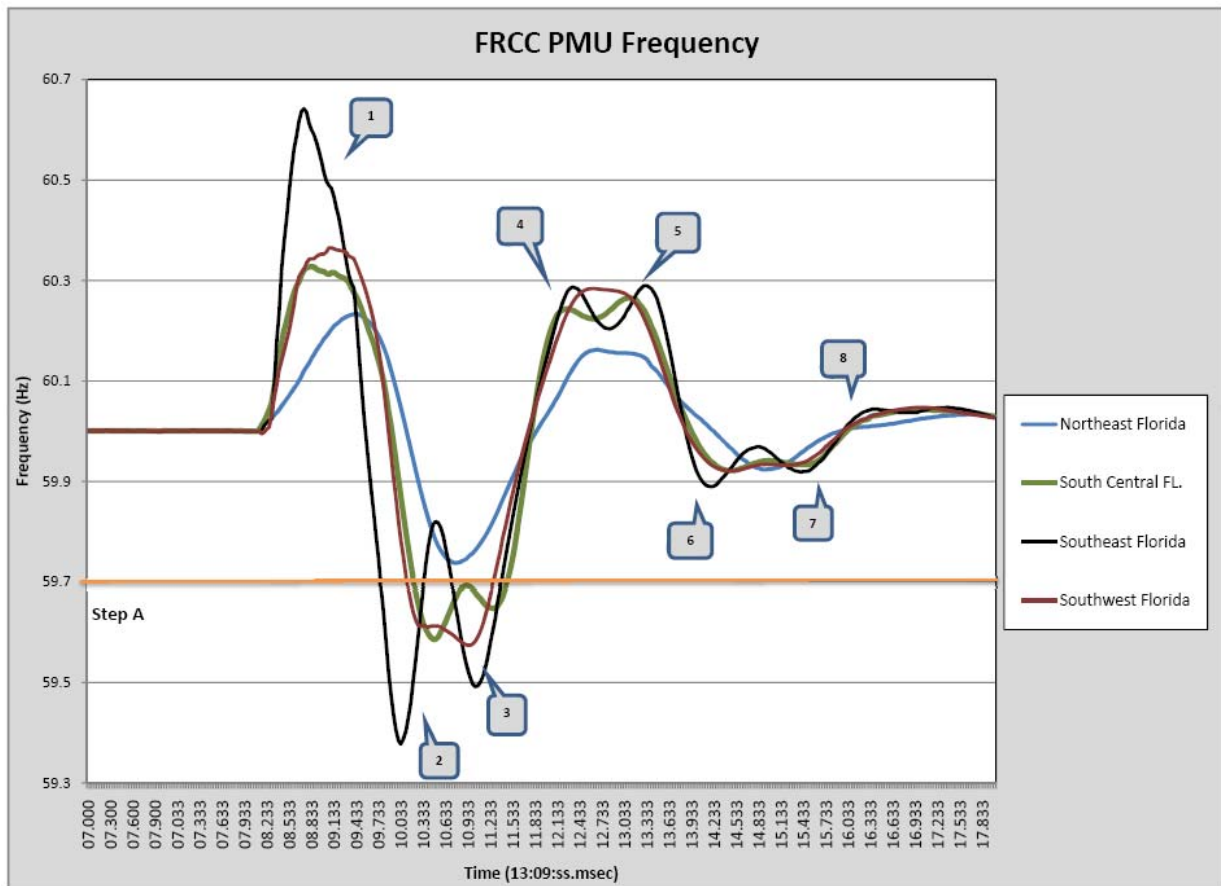
The sequence of events data and frequency measurement equipment show that the frequency dropped as low as 59.38 Hz in the Southeast part of the State and as low as 59.738 Hz in the Northeast part of the State. FRCC PMU data illustrated that the frequency swing which originated in the Southeast quadrant had non-uniform impacts on the Regional system frequency radiating northward. (reference Figure 3). The numbered points labeled on Figure 3 indicate the varying frequency peaks and valleys experienced across the Region and generally correspond to the last column of Figure 4 (*Sub-Regional frequency profile – timing sequence of events summary*) that details the timing of the frequency excursions across four geographically distinct areas of the Region. Figures 3 and 4 together help illustrate the frequency swing over time that occurred on the peninsula of Florida.

Figure 3 - Measured frequency perturbation across the Region with timing sequence references

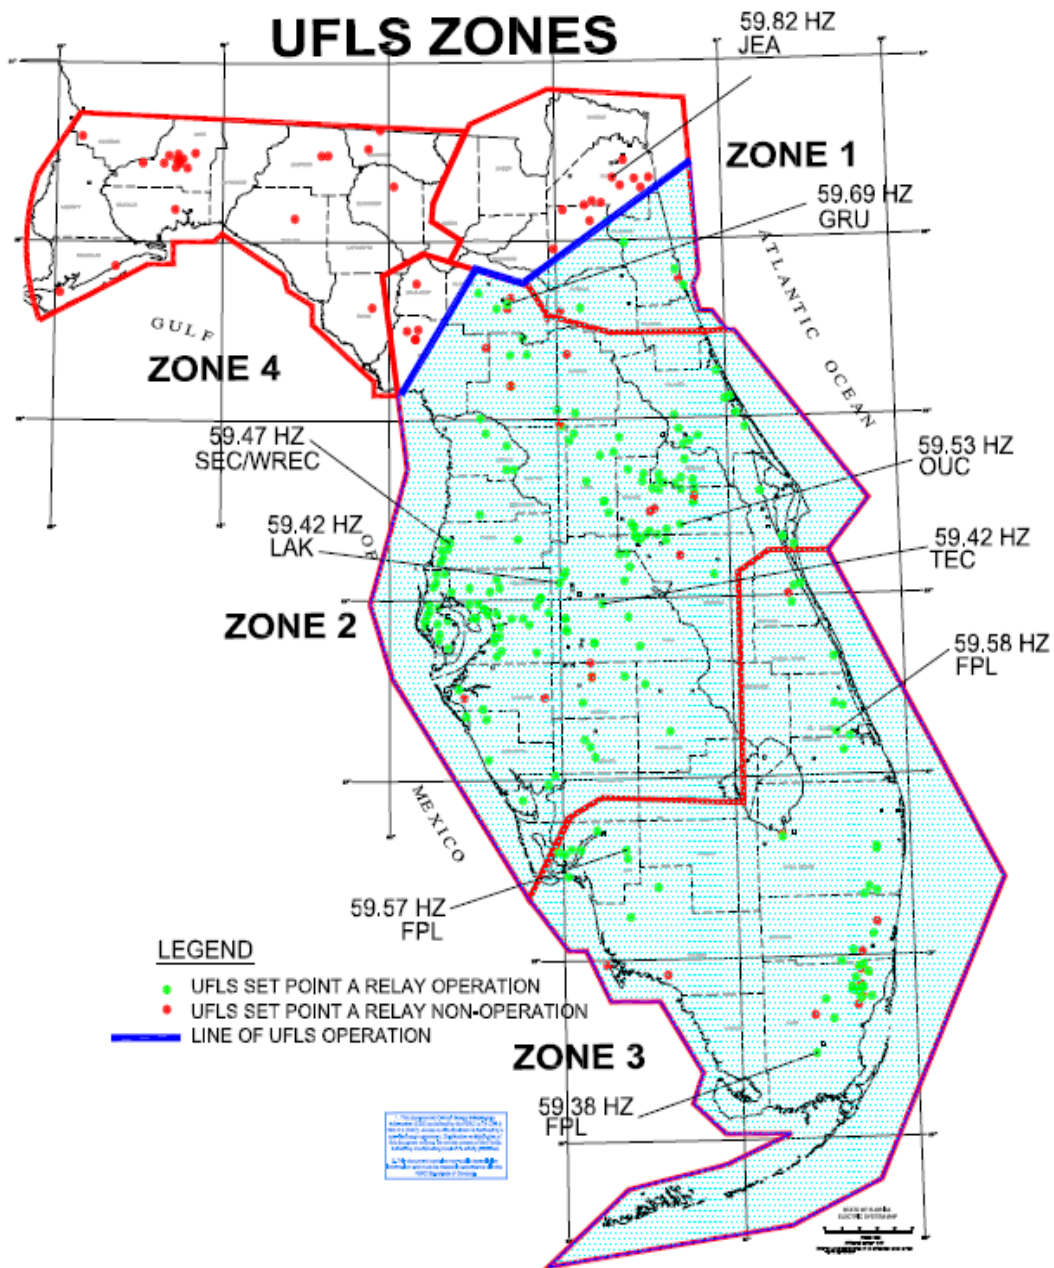
Detailed analysis found that, within the first 20 seconds of the disturbance, 439 (step A) feeders had tripped by UFLS relay actuation (operation) while 138 (step A) feeders had not tripped. All relays that operated were under the step A or A', set points. Figure 6 graphically illustrates the geographic location of FRCC UFLS Zones as well as the step A and A' relay operations and non-operations that occurred on February 26th, 2008. Overall this resulted in the loss of approximately 2,273 MW of load and roughly 632,000 customers. UFLS zones 1, 2 and 3 had operations while zone 4 experienced no operations. As discussed earlier, the long duration of the fault in south Florida caused an electromechanical power imbalance on generators in south Florida that resulted in large swings in frequency. Damping of that frequency perturbation led to the underfrequency conditions measured across the Region.

Figure 6 – Approximate geographic location of FRCC UFLS step A - relay operations
