**Re: Electric Power Research Institute 2015 Technical Report
Docket No. RM12-4-000**

Supplemental Testing to Confirm or Refine Gap Factor Utilized in Calculation of Minimum Vegetation Clearance Distances (MVCD)

Tests: Results and Analysis

2015 TECHNICAL REPORT

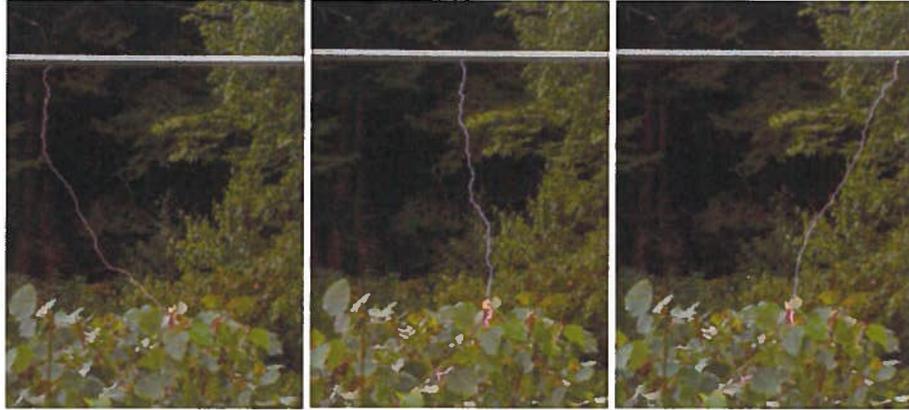
*Figure 1-1
Flashovers to Vase, 230 kV, Vertical, Natural Vegetation*

More specifically, the 230 kV MVCD to a vase shaped natural tree, based on gaps and impulses calculated for a gap factor of 1.3, did not pass the withstand test performed at expected transient overvoltage level given in the MVCD FAC003-2. Photographs of the flashovers that occurred during the withstand test are shown in Figure 1-1.

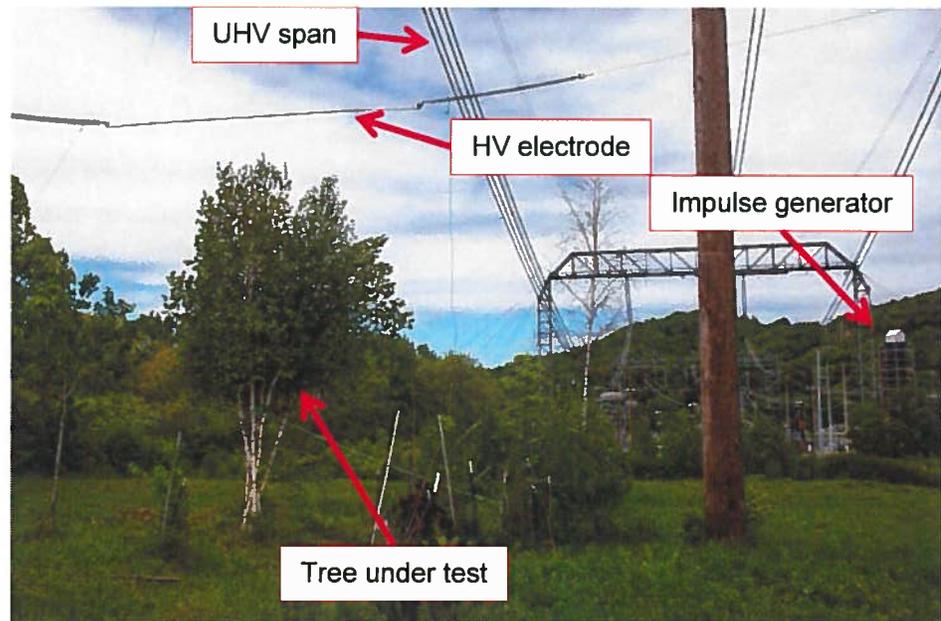
Figure 2-2
Photograph of test set up. Vertical gap distances were set using a winch.

The test *setup* was the same as that previously used for the withstand tests during the 2014 minimum vegetation clearance distance tests [10]. The tree was tested without the addition of a metal rod or wooden dowel to serve as ground electrode. A general view of the test setup is shown in Figure 2-2.

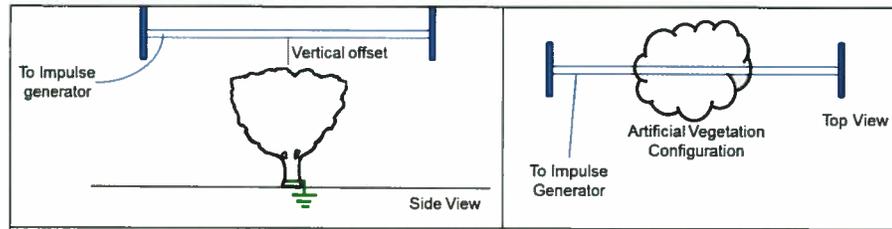
Figure 2-3
Connections to the conductor for the supplemental minimum vegetation clearance tests simulating the Grow-in condition (i.e. vertical gap to artificial vegetation)

To minimize interference with the electric field profile between the simulated conductor and the tree, the connection from the impulse generator to the electrode were made as far as practical from the Artificial Vegetation Configuration as shown conceptually in Figure 2-3. The length of the aluminum tube was chosen to be sufficient to minimize any end effects.

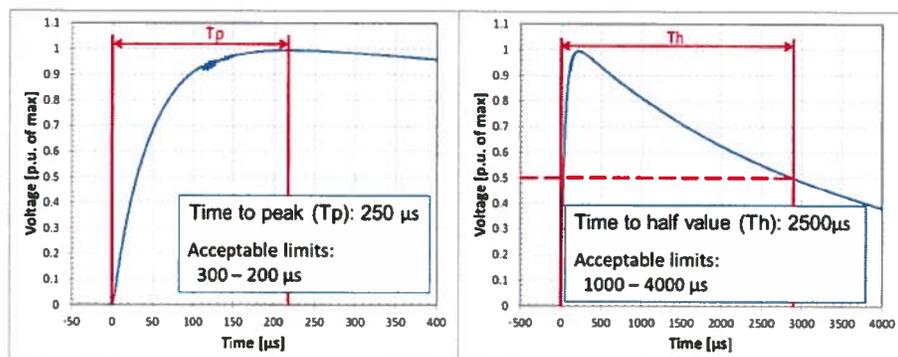
Figure 2-4

Definition of the Standard Switching Impulse as per IEEE Standard 4.

- Time to peak (T_p): $100 \mu\text{s} \pm 20\%$
- Virtual time to half-value (T_2): $2500 \mu\text{s} \pm 60\%$

The definition of these wave parameters are presented in Figure 2-4.

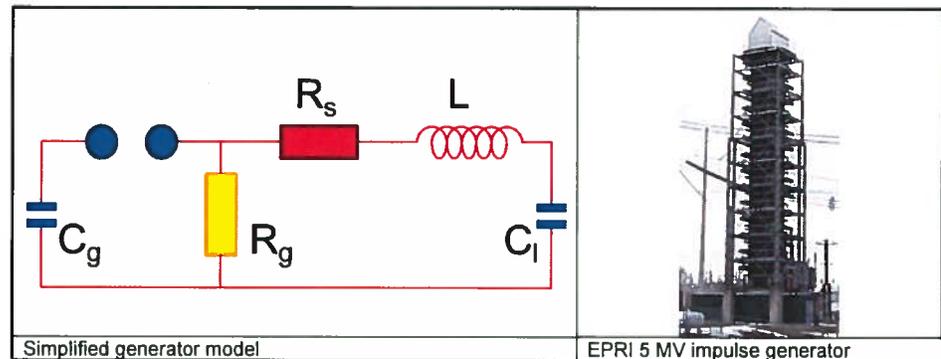
Figure 2-5
The test circuit for Lightning Impulse Tests

The lightning impulse tests have been performed with the EPRI 28 stage conventional Marx generator circuit as shown in Figure 2-5. It has the following internal parameters:

- Capacitance per stage: $0.5 \mu\text{F}$
- Self-inductance per stage: $3.64 \mu\text{H}$
- Internal resistance per stage: 0.2Ω

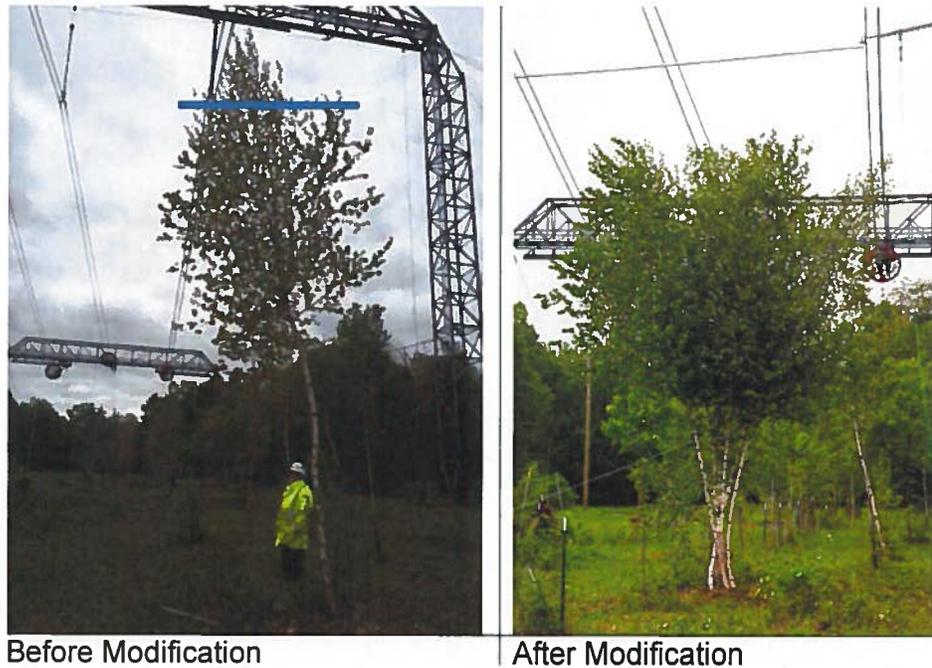
Figure 2-6
Vase Shaped Tree selected for testing.

The supplemental tests were performed on a Natural, Vase-shaped tree, which was selected from the trees available for this purpose at the Lenox facility. This tree is shown in Figure 2-6 on the left. Additional freshly cut trees were lashed to the selected tree to achieve the required tree shape and size. This tree was also trimmed by cutting back the outgrowth to produce the characteristic “flat top” of a vase shaped tree. The modified tree, subjected to testing, is shown in Figure 2-6 on the right. Furthermore, steps were taken to ensure that all the trees used to build up the test specimen were bonded together electrically with copper wires and screws.

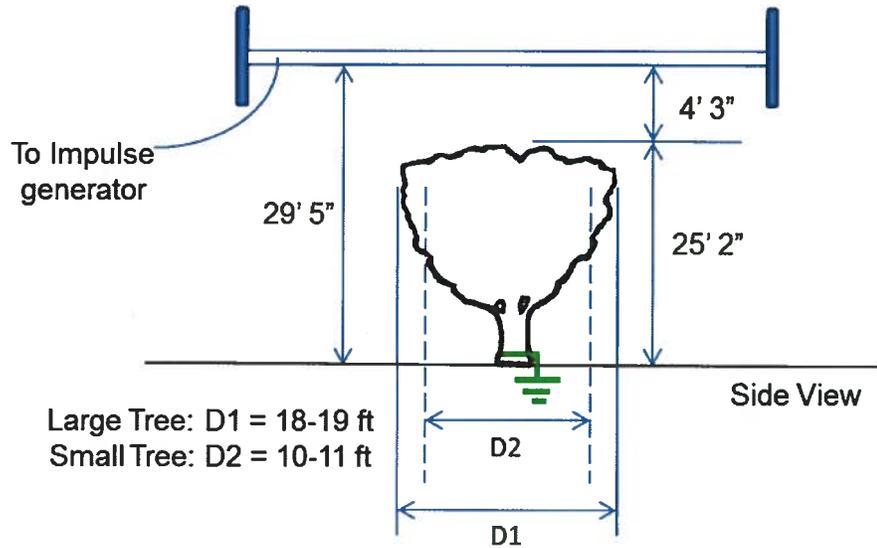
Figure 2-7
Actual test object dimensions and gap size

As shown in Table 3-1, the switching impulse tests were performed on two tree diameters. The large tree, with a target diameter of 200", comprised a total of 7 trees lashed together. For the smaller diameter tree, two of the additional trees were removed. The dimensions of test object "as tested" were measured before and after the test and are presented in Figure 2-7.

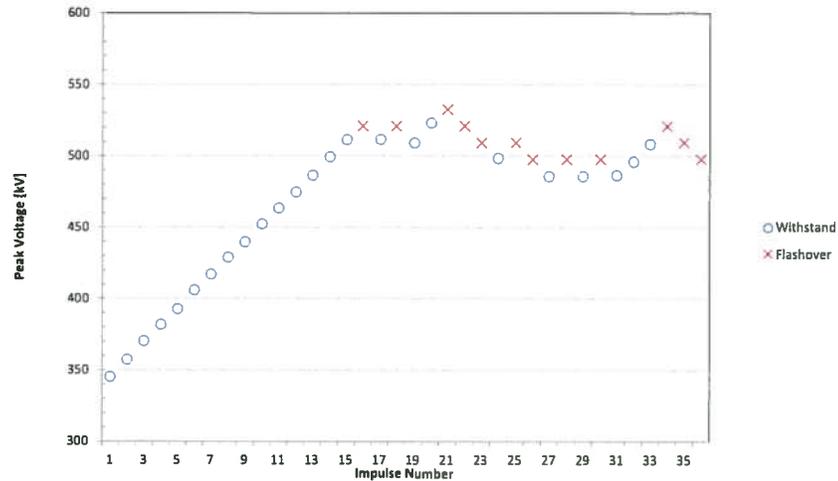
Figure 3-1
 Test sequence for the up-down test on the large diameter tree

The test sequence applied to the large diameter tree is presented in Figure 3-1. During this test a total of 36 impulses were applied to the test object. The first part of this test, comprising 15 impulses with increasing amplitude, is aimed at finding the voltage amplitude necessary for flashover. The next 21 impulses (from the first flashover onwards) form the up-down test. The data of these impulses are used to estimate the CFO (U_{50}).

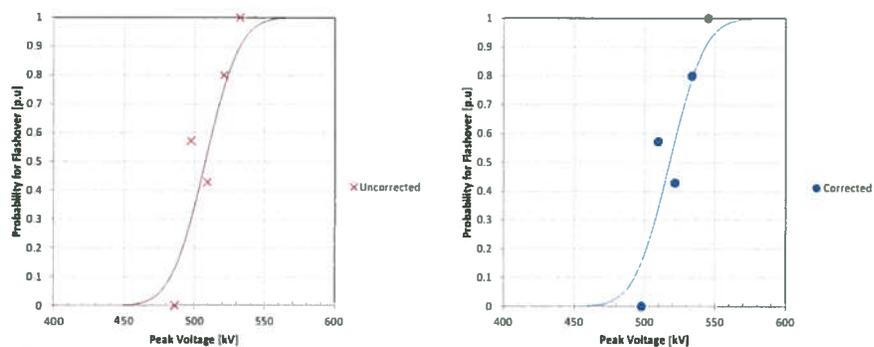
Figure 3-2
Test on the large diameter tree: Probability for Flashover as a Function of the Applied Switching Impulse Voltage.

The results from the up-down test were analyzed with the method of maximum likelihood to estimate the critical flashover voltage (also named the V_{50} ; or the voltage with a 50% flashover probability), and the standard deviation of the flashover characteristic. The 95% confidence interval of these parameters was also calculated.

The test results are presented in Table 3-2. Both the un-corrected and corrected values are presented. The corrected values refer to the flashover values which are corrected for atmospheric conditions as defined in IEEE Std. 4. The results are also presented graphically in Figure 3-2. Direct observation of impulse withstands and flash-overs indicate that the flashover characteristics do not change during this test.

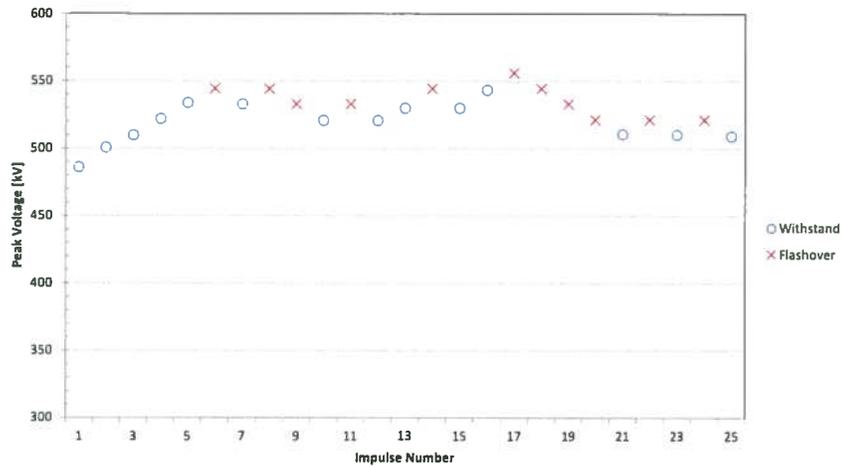
Figure 3-3
Test sequence for the up-down test on the small diameter tree

The test sequence applied to the small diameter tree is presented in Figure 3-3. During this test a total of 25 impulses were applied to the test object. The first part of this test, comprising 5 impulses with increasing amplitude, is aimed at finding the voltage amplitude necessary for flashover. The next 20 impulses (from the first flashover onwards) form the up-down test. The data of these impulses are used to estimate the CFO (U_{50}).

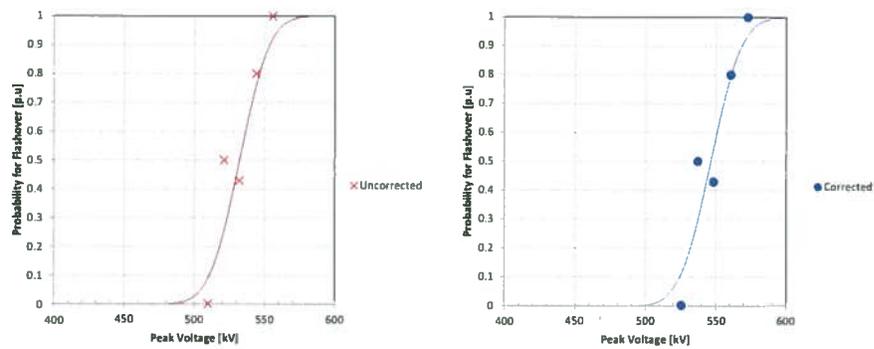
Figure 3-4
Test on the small diameter tree: Probability for Flashover as a Function of the Applied Switching Impulse Voltage.

The results from the multiple level test were analyzed with the method of maximum likelihood to estimate the critical flashover voltage (also named the V_{50} ; or the voltage with a 50% flashover probability), and the standard deviation of the flashover characteristic. The 95% confidence interval of these parameters was also calculated. The test results are presented in Table 3-3. Both the uncorrected and corrected values are presented. The corrected values refer to the flashover values which are corrected for atmospheric conditions as defined in IEEE Std. 4. The results are also presented graphically in Figure 3-2. Direct observation of impulse withstands and flash-overs indicate that the flashover characteristics do not change during this test.

The CFO, at sea-level, is therefore determined as 546 kV. This CFO is now compared to that of a rod-plane gap with the same gap length of 4.25 feet (1.30 m) which according to the Gallet equation should have a CFO of 475 kV. The gap factor is therefore calculated as $k_g = 546/475 = 1.15$.

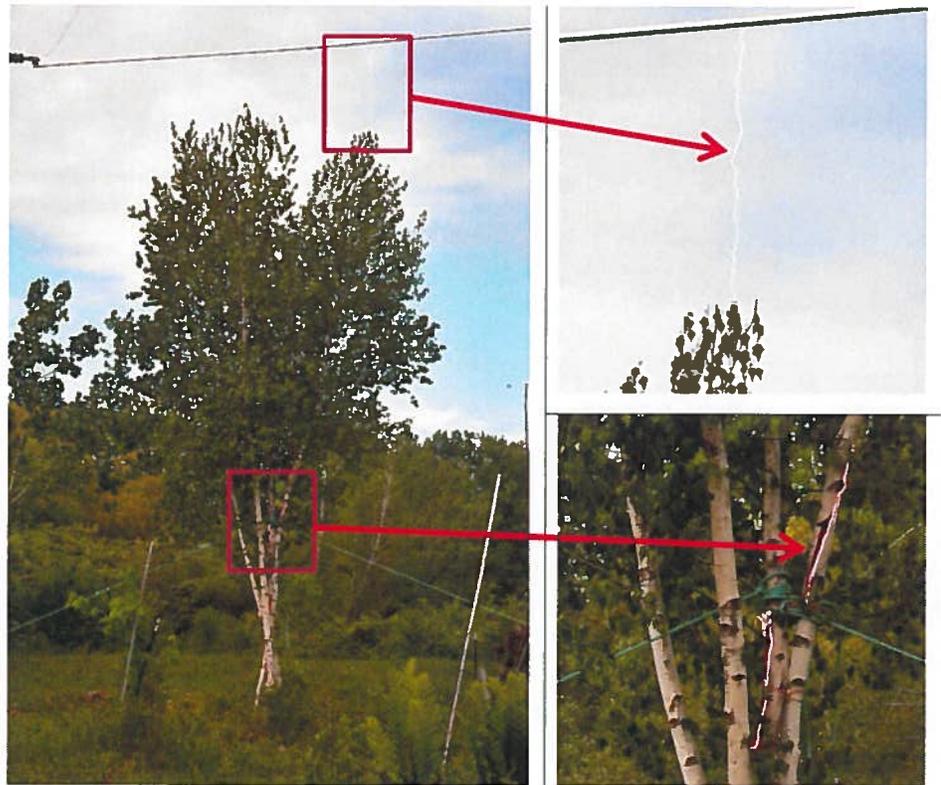
Figure 3-5
An example of a visible flashover to the tree that occurs at impulse voltages with amplitude of over 780 kV.

After all tests were completed, a series of additional impulses were applied to the tree to determine if there was a change in flashover behavior at higher impulse amplitudes. It was found that visible discharges started occurring for voltage amplitude of 788 kV and above. An example of such a discharge is presented in Figure 3-5. While still faint, a discharge could be seen across the air gap and following along the tree stem to the ground – see detail photos on the right in Figure 3-5.

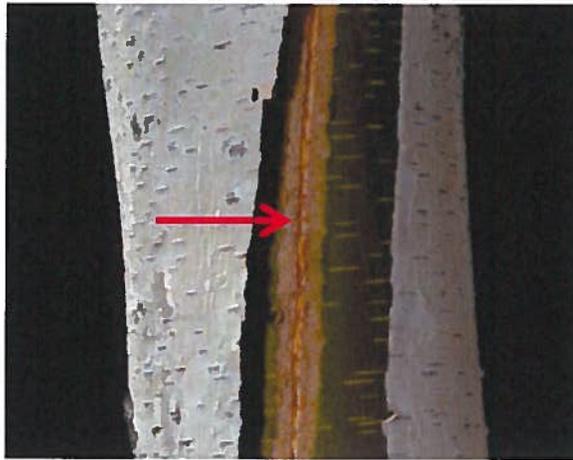
*Figure 3-6
An example of the flashover track along the tree stem.*

After these discharges a clear flashover path was observed on the tree stem. An example is shown in Figure 3-6.

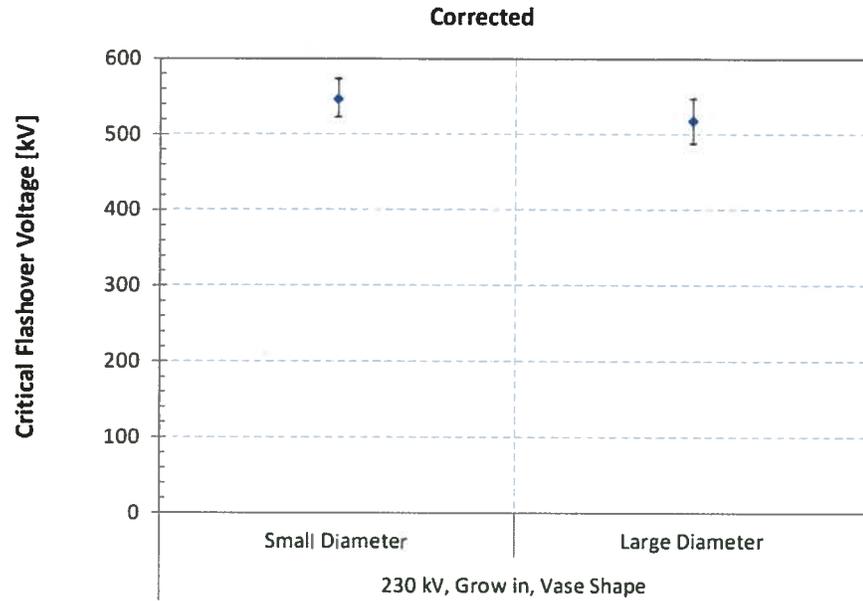
Figure 3-7
 Comparison of the flashover strength under switching impulse of two tree diameters: 230 kV Vertical Configuration, Vase Shaped Tree. (The 95% confidence intervals of the CFO estimates are indicated by the error bars)

For comparison purposes the test results. Corrected to standard atmospheric conditions are presented side by side in Table 3-4. From these values it can be seen that the flashover strength of the gap to the small diameter tree was 5.4% over that of the large diameter tree. The results are also shown graphically in Figure 3-7.

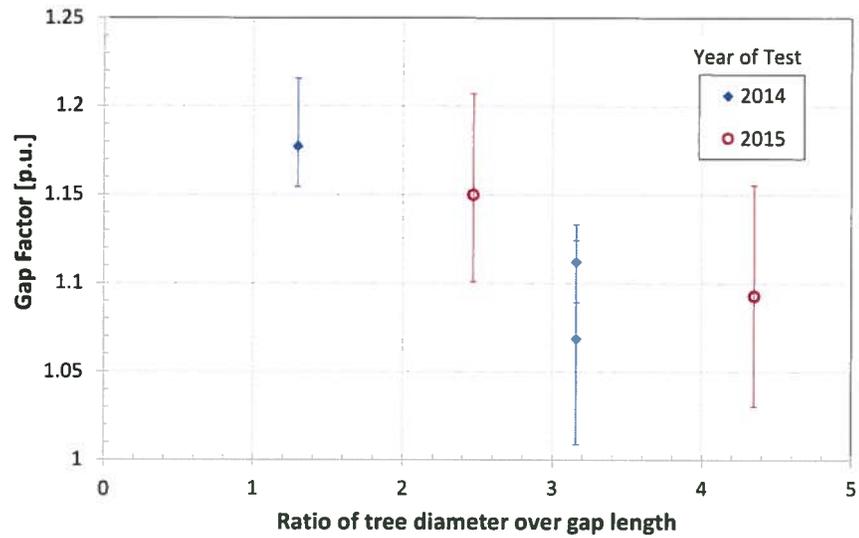
*Figure 3-8
Comparison of the flashover strength under switching impulse for various tree diameters: 230 kV Vertical Configuration, Vase Shaped Tree. (The 95% confidence intervals of the CFO estimates are indicated by the error bars)*

In Figure 3-8 a comparison is made of the 2014 and 2015 results for the 230 kV; grow in – vase shaped tree. This comparison is made on the basis of the ratio of the canopy diameter to the gap length because different gap lengths were tested in 2014 and 2015. The 95% confidence intervals for each gap factor are also shown to indicate the reliability of the estimated CFO values.

This comparison indicates that the gap factor stabilizes around 1.1 for ratios of the canopy diameter to the gap length greater than 3. It may therefore be concluded that the gap factor of a conductor over a wide tree approaches that of a conductor-plane gap, which is $k_g = 1.1$. This conclusion is made with some reservation considering the relatively few tests performed that resulted in a relatively large confidence region (i.e. 1.03 to 1.15). A conservative approach would be, therefore, to base the MVCD calculation on a gap factor which falls below the confidence region.

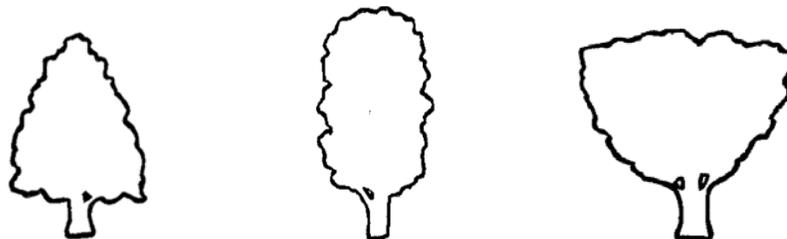
Figure 1: Vegetation Shapes Tested for Vertical Conductor-to-Vegetation Gaps – Pyramidal, Columnar, and Vase

Vegetation species vary both regionally and by site type. The test was designed to cover the range of vegetation shapes and types expected in and around transmission rights-of-way for all NERC Regional Entities. It was important to test various vegetation shapes, as they produce varying influences on the electric field between a transmission line conductor and vegetation. These influences were found to affect the probability of flashover between a conductor and vegetation and must be considered to determine the minimum value of the gap factor for a given conductor-to-vegetation gap configuration. The different types of vegetation were organized into three basic shapes, as illustrated in Figure 1:

- Pyramidal – Conifers (e.g., spruce, fir, pine) that have a well-defined central leader.
- Columnar – Deciduous trees that may exhibit less central dominance, commonly referred to as having a random form.
- Broadly vase-shaped – Involves larger trees with crowns that have been maintained by pruning. This is produced by the inability to remove trees within the conductor zone. The crown form would be asymmetrical or perhaps even “flat-topped.”

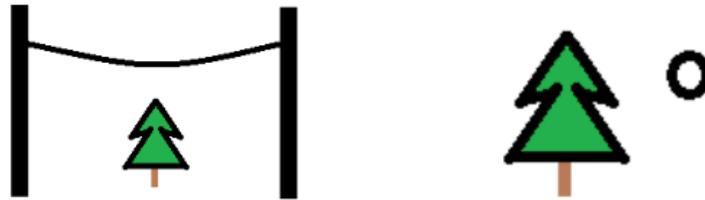
Figure 2: Vertical (Grow-in) and Horizontal (Blow-in) Conductor-to-Vegetation Gap Configurations

The physical arrangements of both the vegetation and transmission line conductors were also considered when determining the types of conductor-to-vegetation gap configurations that were tested. Encroachment between vegetation and transmission lines could occur vertically (from below) or horizontally (from the side), as illustrated in Figure 2. Both vertical and horizontal conductor-to-vegetation gap configurations were incorporated into the test plan. All three vegetation shapes were tested in the vertical conductor-to-vegetation gap configuration, since they may produce varying electric field influences between a conductor and vegetation, as noted above.

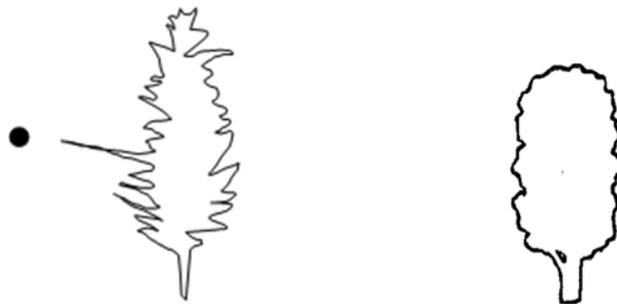
Figure 3: Vegetation Shapes Tested for Horizontal Conductor-to-Vegetation Gaps – Branch Protruding Toward Conductor and Columnar

Concerning horizontal conductor-to-vegetation gap configurations, vegetation shape varies based on maintenance practices. When viewed from the side, maintained vegetation appears planar in shape. However, vegetation that has not been maintained may have a less-consistent appearance, with branches that protrude out toward a transmission line. The horizontal conductor-to-vegetation gap configurations were tested for both columnar geometry (i.e., maintained look) and modified columnar form of vegetation that simulates a branch protruding toward a transmission line, as illustrated in Figure 3.
