## Vegetation-Related Transmission Outage Report Third Quarter 2008

The NERC Board of Trustees Compliance Committee has reviewed and accepted this Vegetation-Related Transmission Outage Third Quarter 2008 Report.

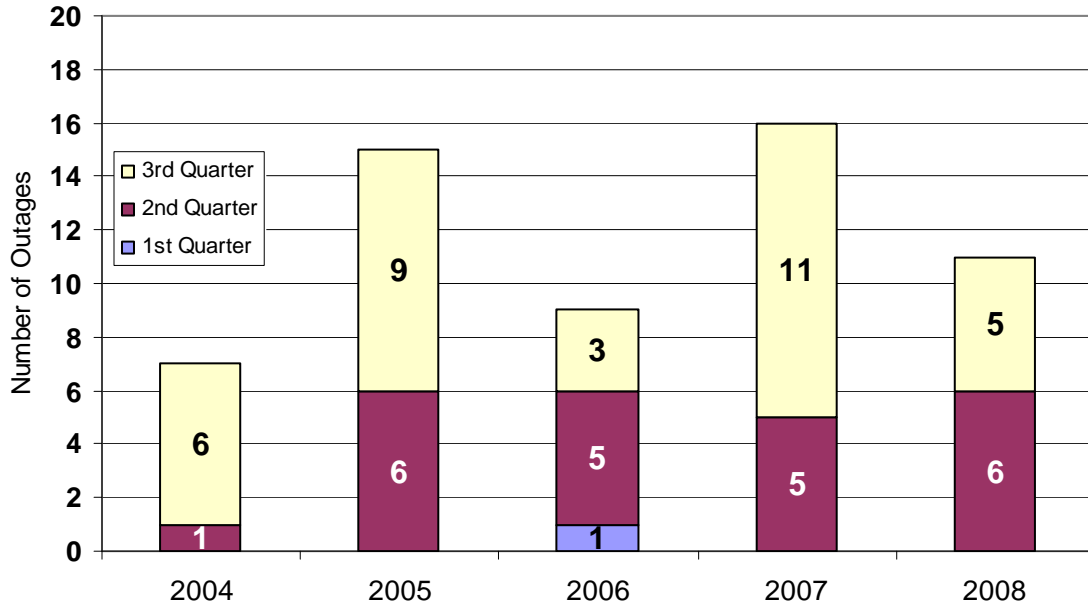
**Figure 1: Category 1 — Grow-ins from within the Right-of-Way**

Figure 1 illustrates the number of outages caused by vegetation growing into transmission lines from within the right-of-way that have been reported since 2004. Figure 2 provides this information by voltage class for each year.

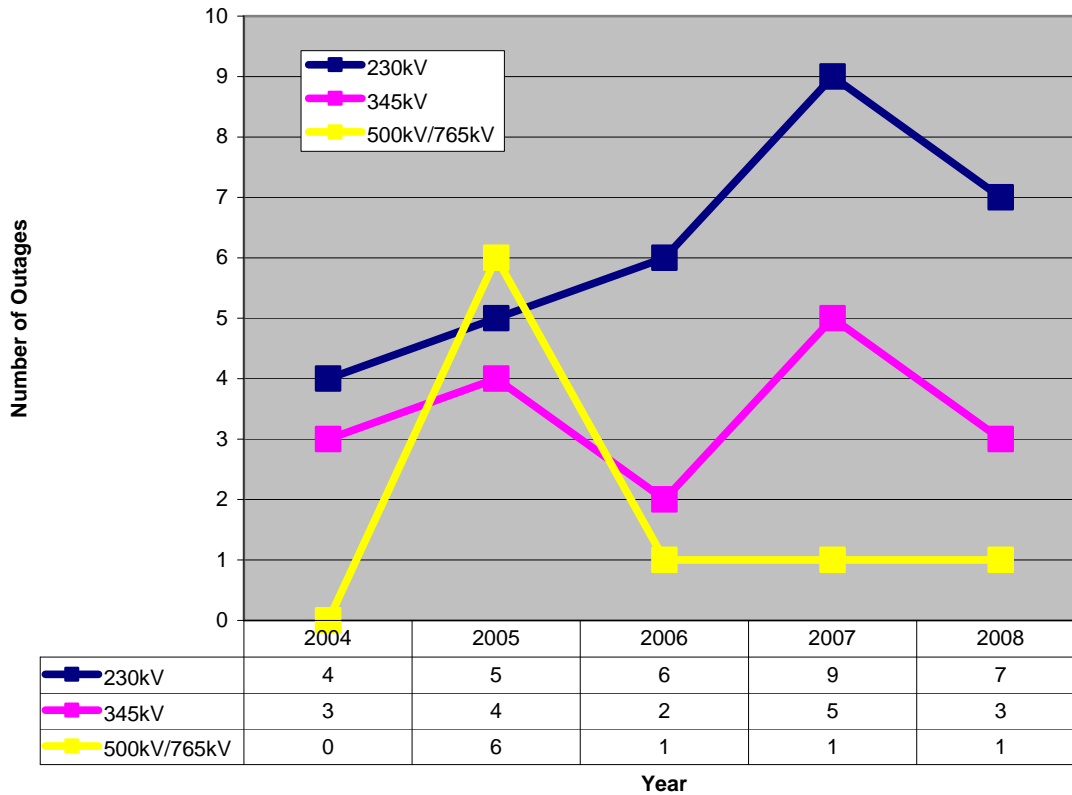
**Figure 2: Category 1 — Grow-In Vegetation Related Outages of 230 kV and Higher Transmission within the Right-of-Way by Voltage Class**
