UTILITY VEGETATION MANAGEMENT FINAL REPORT

MARCH 2004

**FEDERAL ENERGY REGULATORY COMMISSION
UNITED STATES GOVERNMENT**

**COMMISSIONED TO SUPPORT THE FEDERAL INVESTIGATION
OF THE AUGUST 14, 2003 NORTHEAST BLACKOUT**

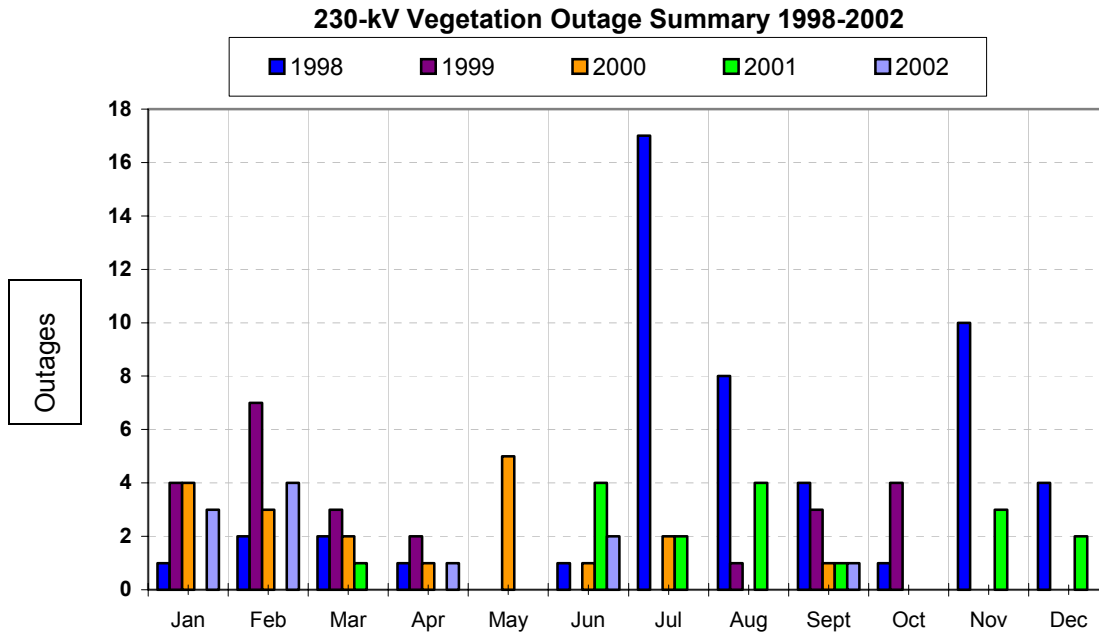
While this is a more common problem on distribution lines, transmission tree-related outages are also experienced by utilities on a regular basis. For example, the following chart, provided by the Western Systems Coordinating Council (WSCC), illustrates the frequency of 230kV tree-related outages experienced on member utility systems in the west from 1998-2002.

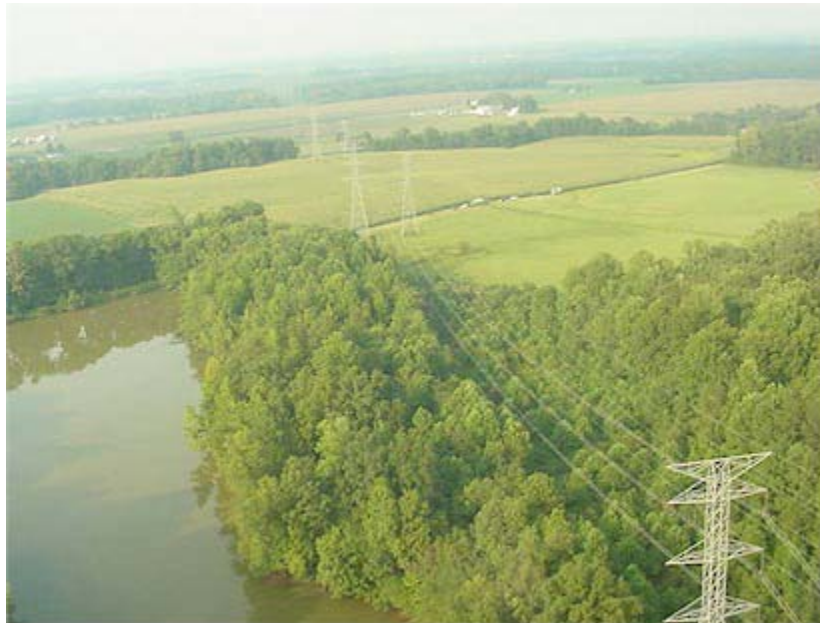
Work on this span on the Columbus – Bedford 345kV line had been halted various times by the owner of the property. The owner of the property had severely limited the ability to achieve necessary clearances and to apply herbicides to control future growth. This landowner has successfully halted work from proceeding on several occasions. This included the homeowner obtaining a court-granted temporary injunction against the utility.

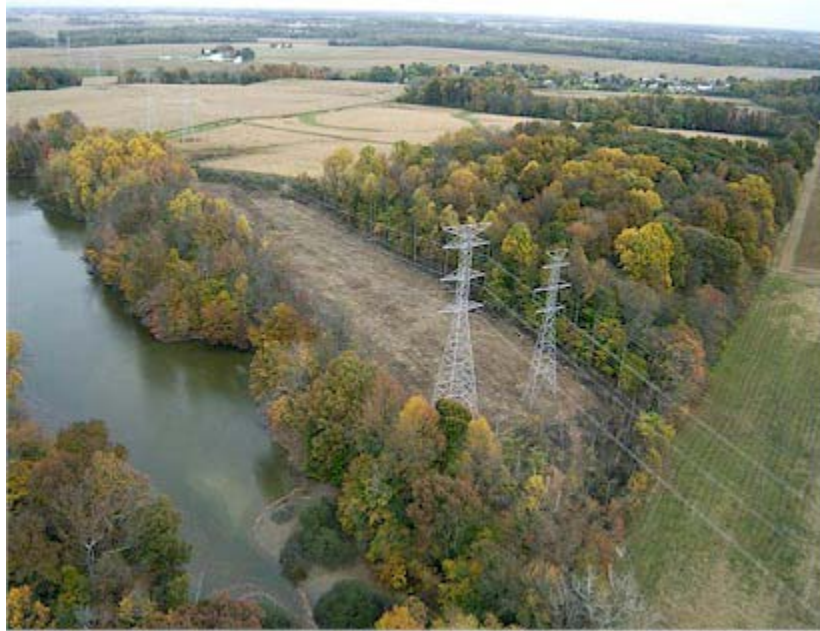
The required work was finally completed on October 9, 2003 as depicted in the photo below.

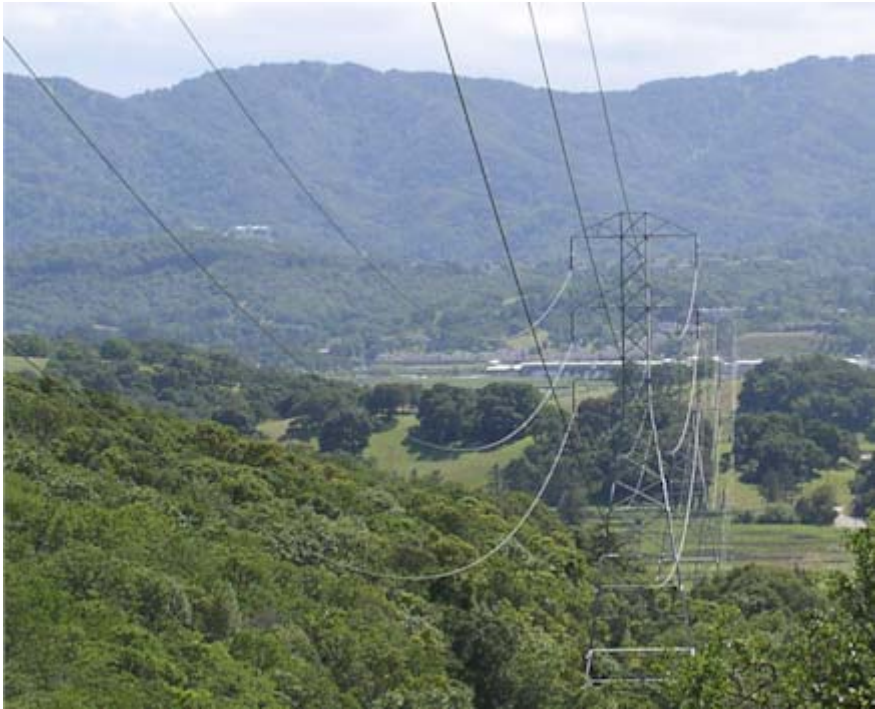
Transmission Line

The following photos depict typical transmission and distribution facilities.

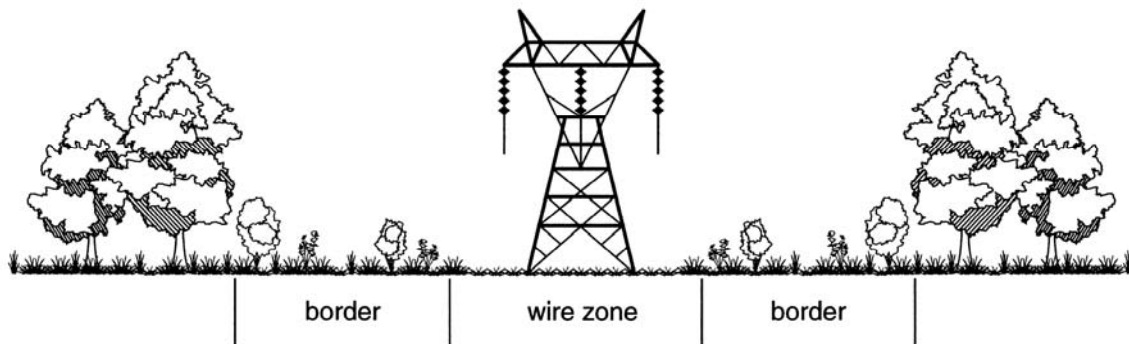
Bramble and Byrnes Wire Zone – Border Zone (From Yahner, Bramble and Byrnes, 2000)

There is industry consensus as to how a transmission ROW should be established and maintained. From an electric reliability standpoint, it simply requires managing vegetation so that it cannot grow into, or fall onto the energized facilities. It requires creating a predictable and low-growing environment of vegetation under and adjacent to the ROW. The following graphic illustrates this simple concept.

As the graphic describes, this concept is typically referred to as the Wire Zone - Border Zone model, and it has, based on years of research¹³, been proven to be effective in reducing and/or eliminating outages related to vegetation on transmission ROWs. In addition, this research has proven that the Wire Zone - Border Zone model generates a great many more benefits than just reducing outages. These benefits include reduced long-term maintenance costs, improved habitat for wildlife, biodiversity, and wildland fire mitigation.

While we recommend that this model be used wherever possible, there are locations where this may not be practical. There are locations where transmission lines are not located on clearly defined and documented ROWs. These lines may also be located in more urban areas where the Wire Zone - Border Zone model may not be appropriate due to existing landscaping or property lines. With that said, we do believe that this model should be utilized whenever new lines are built, and wherever existing lines will allow. This model could and should be applied to the vast majority of transmission lines.

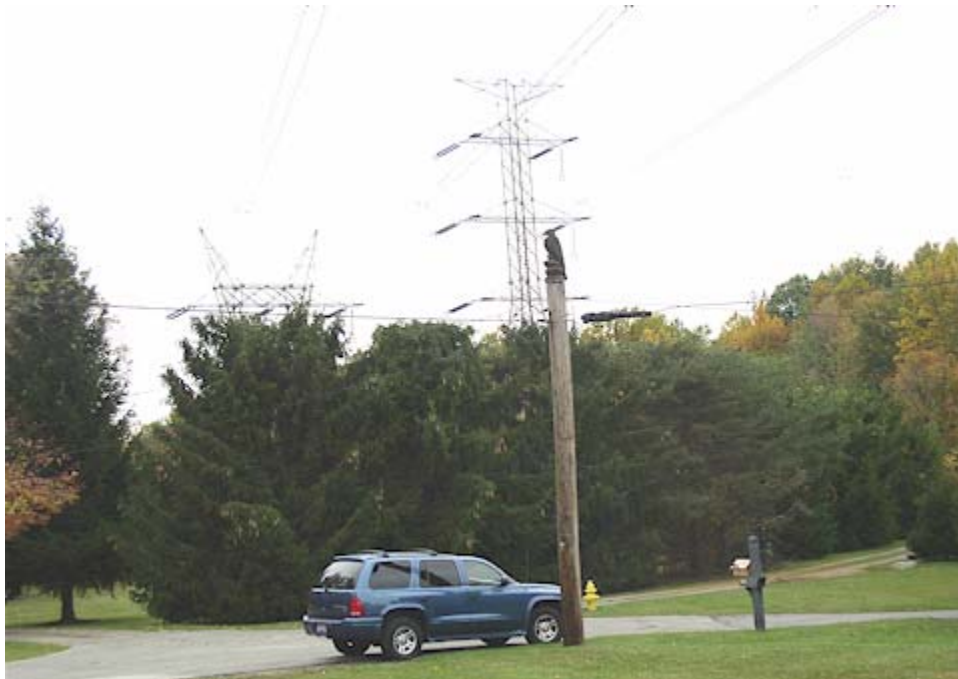
Fortunately, many utility companies have recognized this problem and are taking active measures to “reclaim” these ROWs. Unfortunately, reclaiming ROWs is often a difficult and costly process. One example of these difficulties arises when a landowner plants landscaping within the ROW and the utility allows it to exist over an extended period of time. This problem is illustrated in the following picture taken a few spans away from the fault location that occurred on the Hanna – Juniper 345kV line.

Above, the landowner has planted a row of trees directly underneath the transmission lines. If the utility chooses to enforce the documented easement rights, it would be able to remove this

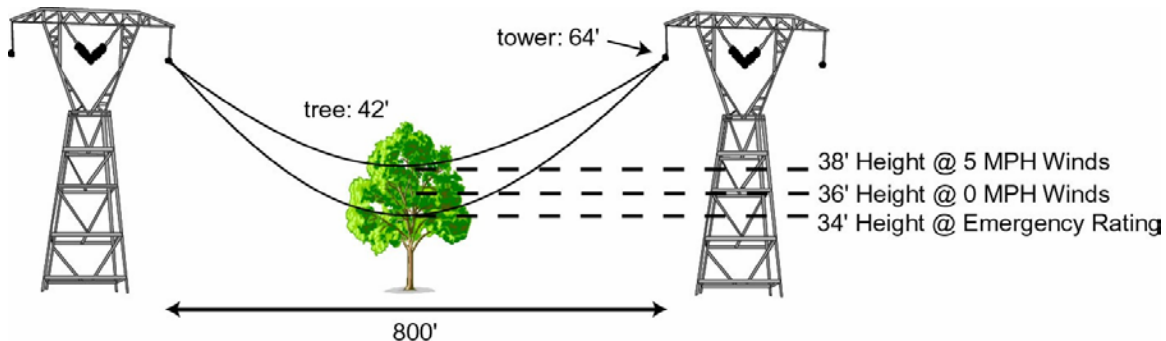
The presence of wind also influences conductor sag. Wind provides a cooling effect on the conductors. This cooling of the conductors reduces the amount of sag that would be encountered in comparison to sag on a calm day.

The following graphic provides an example of how conductor height can vary depending on load and wind velocity.

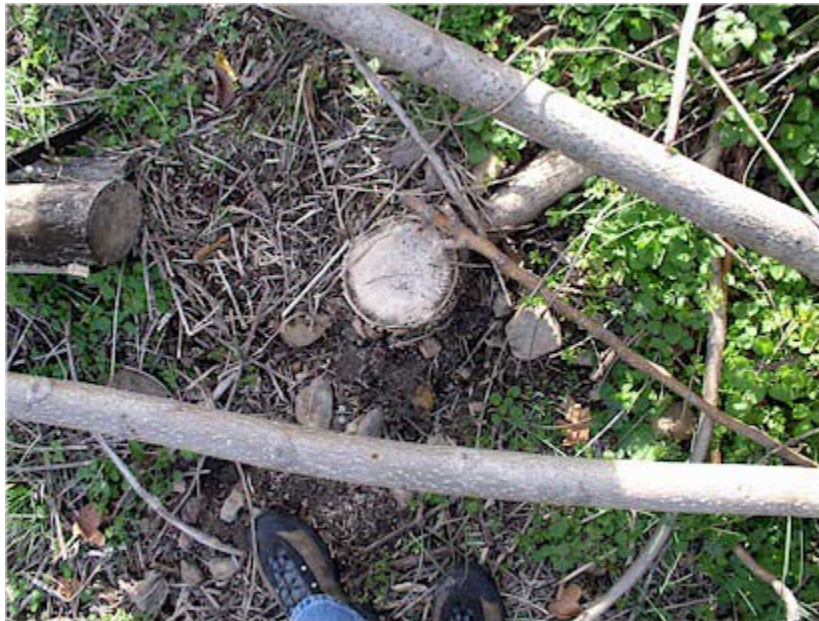
Trees and brush were felled on or after August 14th. Debris was left on site and inspected.

Two ailanthus trees showed evidence of significant fault current damage and were de-barked. One measured 2.5" diameter at ground line, and the other measured 6" diameter at ground line..

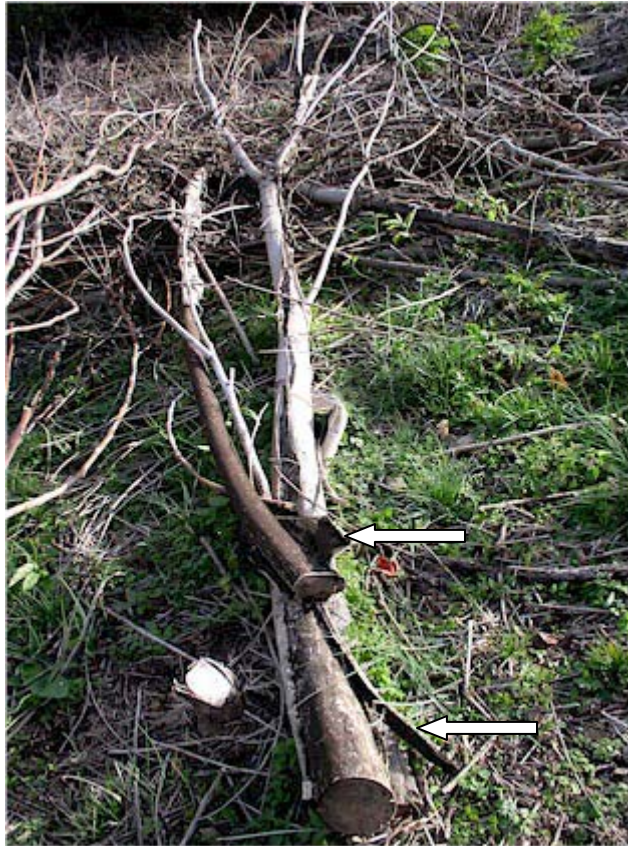
Both trees were estimated to be 30 to 35 feet tall. Other trees in the area showed evidence of fault current damage as well.

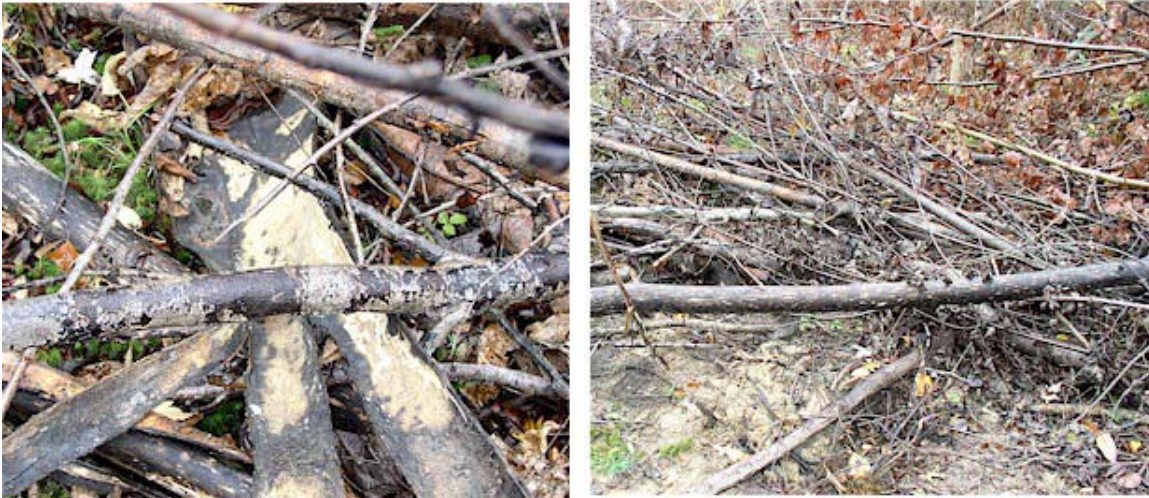
Inspected tree conditions at structure 40376 (20.5%) between towers 40375 and 40376. Trees and vegetation were felled on or after August 14th. Debris and tree parts were inspected on site.

Conductor height measured 44' 9". Tree height measured at 30 feet, although we could not verify location of the stump, or missing section of tree. Obvious significant fault damage to clustered trees. Charred limbs, and de-barked by fault current.

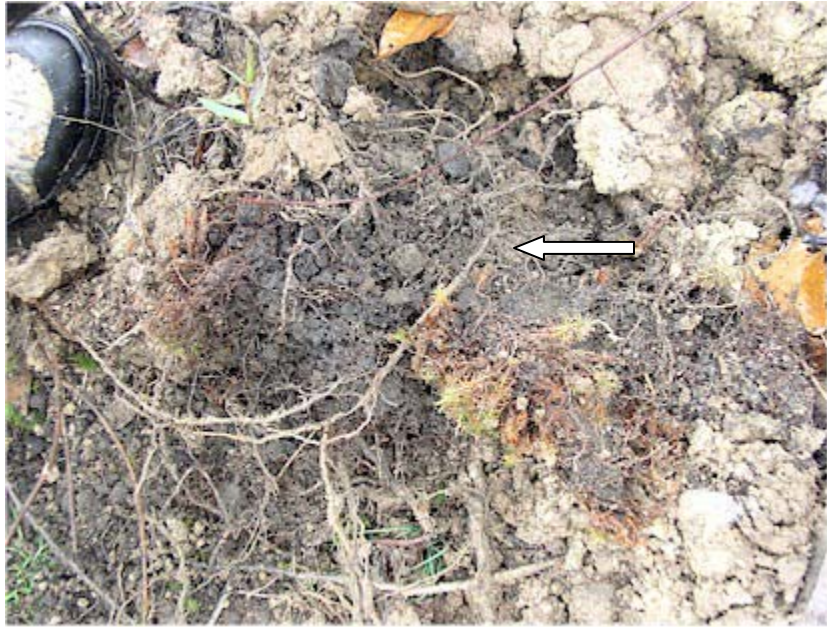
Topsoil in the area of trunk was disturbed, discolored and broken up at site. This is indicative of a higher magnitude fault or multiple faults.

Fourteen year-old tree in the middle of the right-of-way was recently removed.

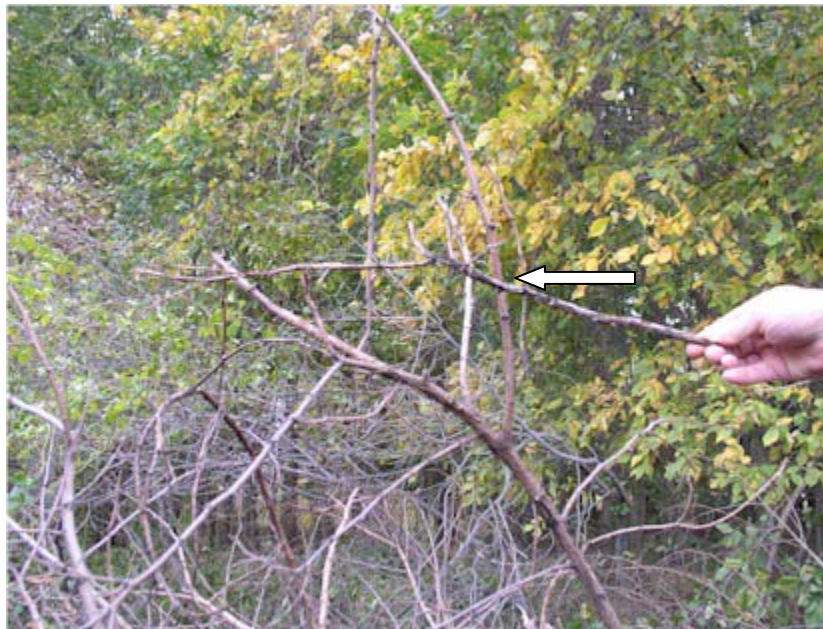
At 17.7%, between towers 42861 and 42860 we inspected vegetation. Trees and brush were felled on or after August 14th. Conductor height measured at 46' 7", tree height measured at 42'. Locust tree showed evidence of fault current damage. Tree damage indicated a lower level of fault current.

Burn marks were observed at 35' 8" up tree. Portions of the tree had been removed from the site making it difficult to determine exact height of contact, implying that the measured height is a minimum, and likely 3-4 feet higher than verifiable.

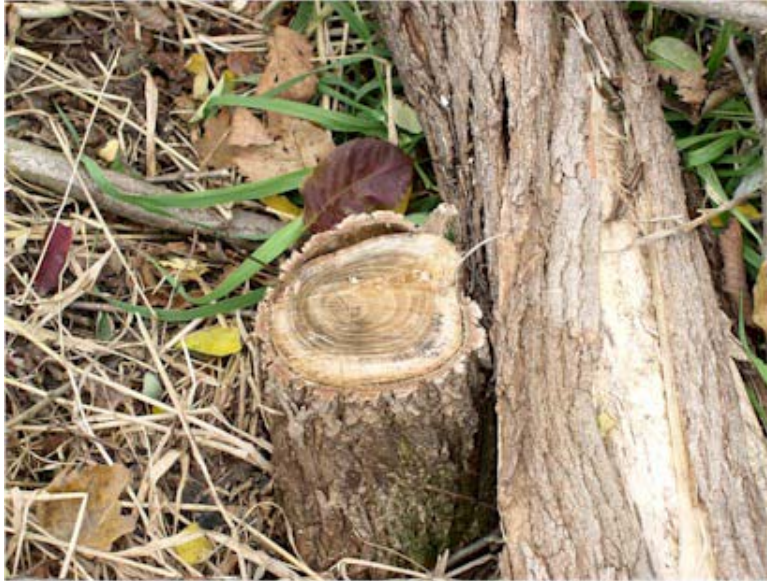
Other vegetation along the right-of-way measured between two and five inches in diameter at ground line. The following photo depicts a tree located in the right-of-way that was over six years old, as indicated by the growth rings.

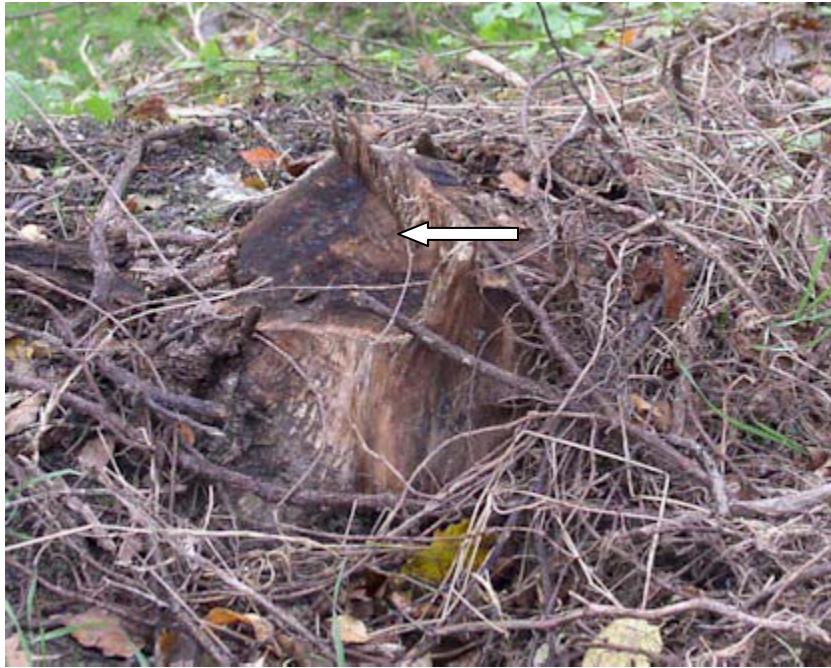
Conductor height measured 48' 9" at fault location. No evidence of tree debris at site. Walnut tree stump measured 14" diameter at ground line.

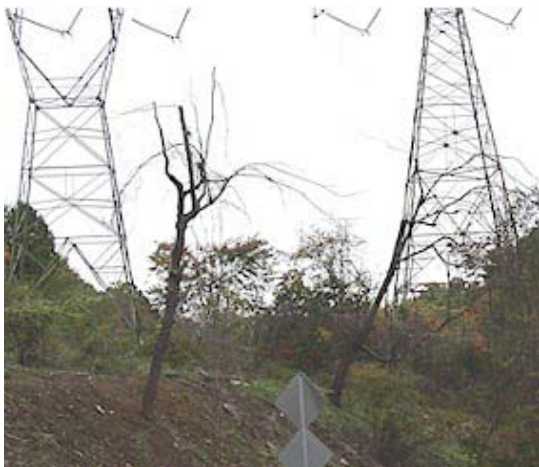
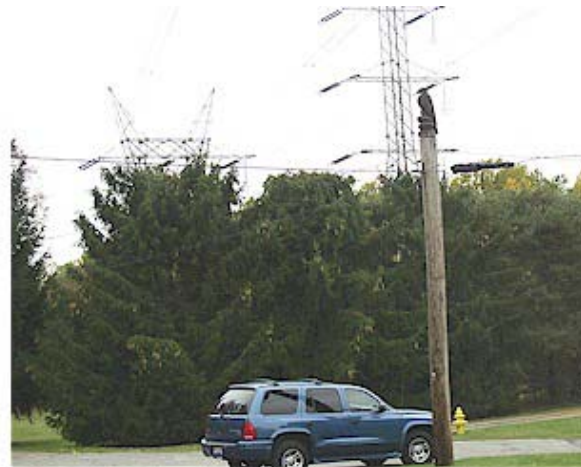
Subsequent clearing left trees and brush that, in our opinion, could have been removed as indicated by the photo below on the left. This photo was taken in the same span as the fault occurred. Other trees were pruned and left in the right-of-way as part of a landscaped area as indicated by the photo on the right. This photo was taken within one span of the fault.

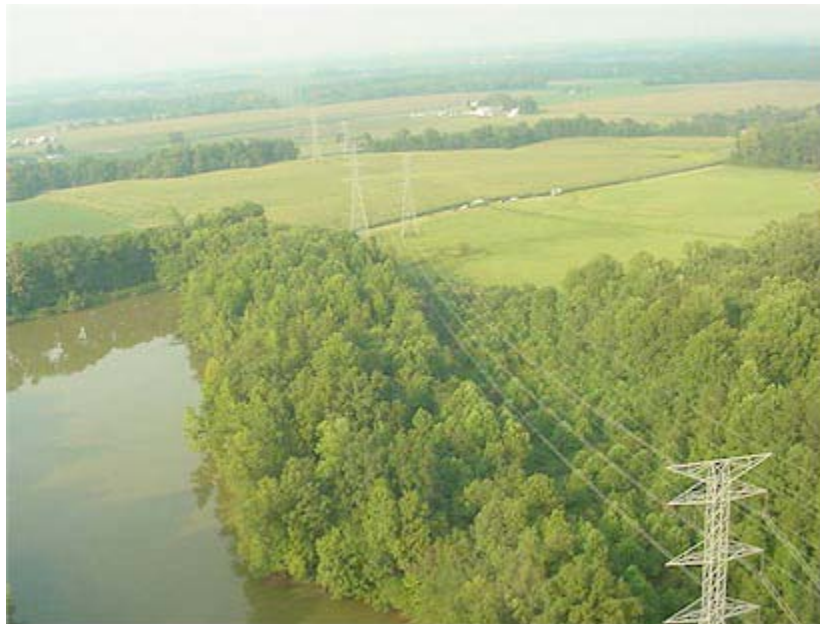
Based on discussions with Cinergy, this transmission line fault occurred as a result of tree contact in one span of the Columbus – Bedford circuit. The photo below was taken prior to August 14th.

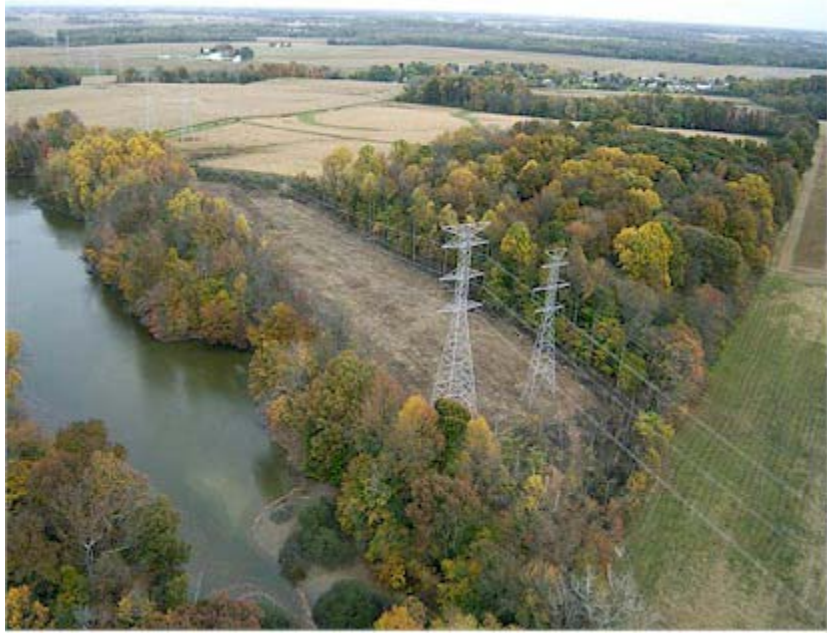
Apparently work on this span had been halted various times by the owner of the property. The owner of the property had severely limited the ability to achieve necessary clearances and to apply herbicides to control future growth. While Cinergy does, in fact, have documented rights to perform this work (documented easement), this landowner has successfully halted work from proceeding on several occasions. This included the homeowner obtaining a court-granted temporary injunction halting work by Cinergy. Note: the required work was finally completed on October 9, 2003 as depicted in the photo below.

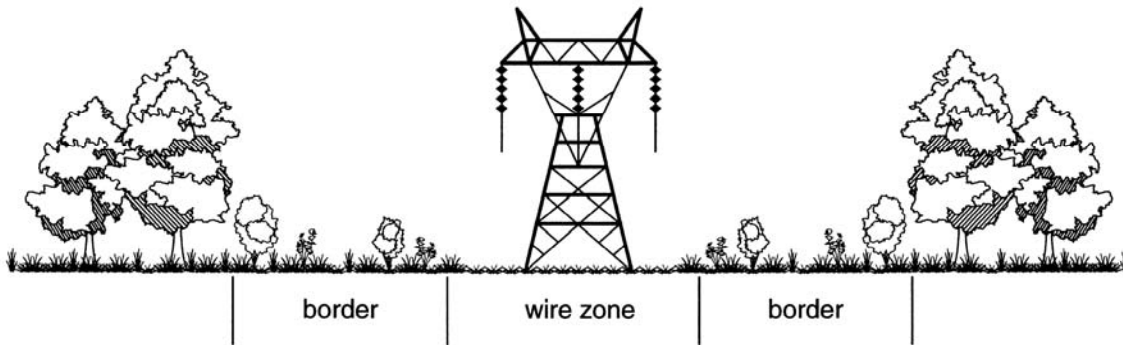
Bramble and Byrnes Wire Zone – Border Zone (From Yahner, Bramble and Byrnes, 2000)

Discussion: As previously mentioned, utilities should work toward the achievement of “Wire Zone – Border Zone” objectives on new and existing ROWs. This involves shifting plant communities found on the current ROW away from predominately tall-growing plant species in favor of plant communities dominated by naturally low-growth plant species. This shift is accomplished by selectively controlling tall-growing plant species, while preserving and encouraging low-growing trees, woody shrubs, grasses, herbs, and forbs. The establishment of this new cover type typically occurs after successive cycles of work and requires a long-term commitment from the utility. In determining the site-specific requirements to achieve the Wire Zone, Border Zone ideal, a variety of vegetation management techniques is considered. These may include biological, chemical, cultural, manual, or mechanical techniques. The choice of the best technique(s) is based on effectiveness, environmental impact, site characteristics, worker and public health and safety concerns, and economics.
